<div>LaCroix Davis <small>LLC</small> <small>ARCHITECTS ENGINEERS AND SCIENTISTS</small></div></div>		
REVISIONS		
NO.	DATE	NOTES
	11/23/08	DRAFT
	12/14/08	FIELD EDITS
	12/17/08	FIELD EDITS
	2/3/09	FIELD EDITS
	2/11/09	FIELD EDITS
	2/21/09	FINAL EDITS
	2/25/09	FINAL EDITS
CLIENT		
STATE OF CALIFORNIA DEPARTMENT OF GENERAL SERVICES (DGS NO. 125828) (AGMT. NO. 3126150)		
PROJECT LOCATION		
BOARD OF EQUALIZATION BUILDING 450 N STREET SACRAMENTO, CA. 95814		
PROJECT		
STATE OF CALIFORNIA, DGS BOE ASSESSMENT (LCD NO. 2372-572)		
DESCRIPTION		
WATER DAMAGE SURVEY		
LOCATION		
9TH FLOOR		
SHT NO.	SHT NAME	
10	A9

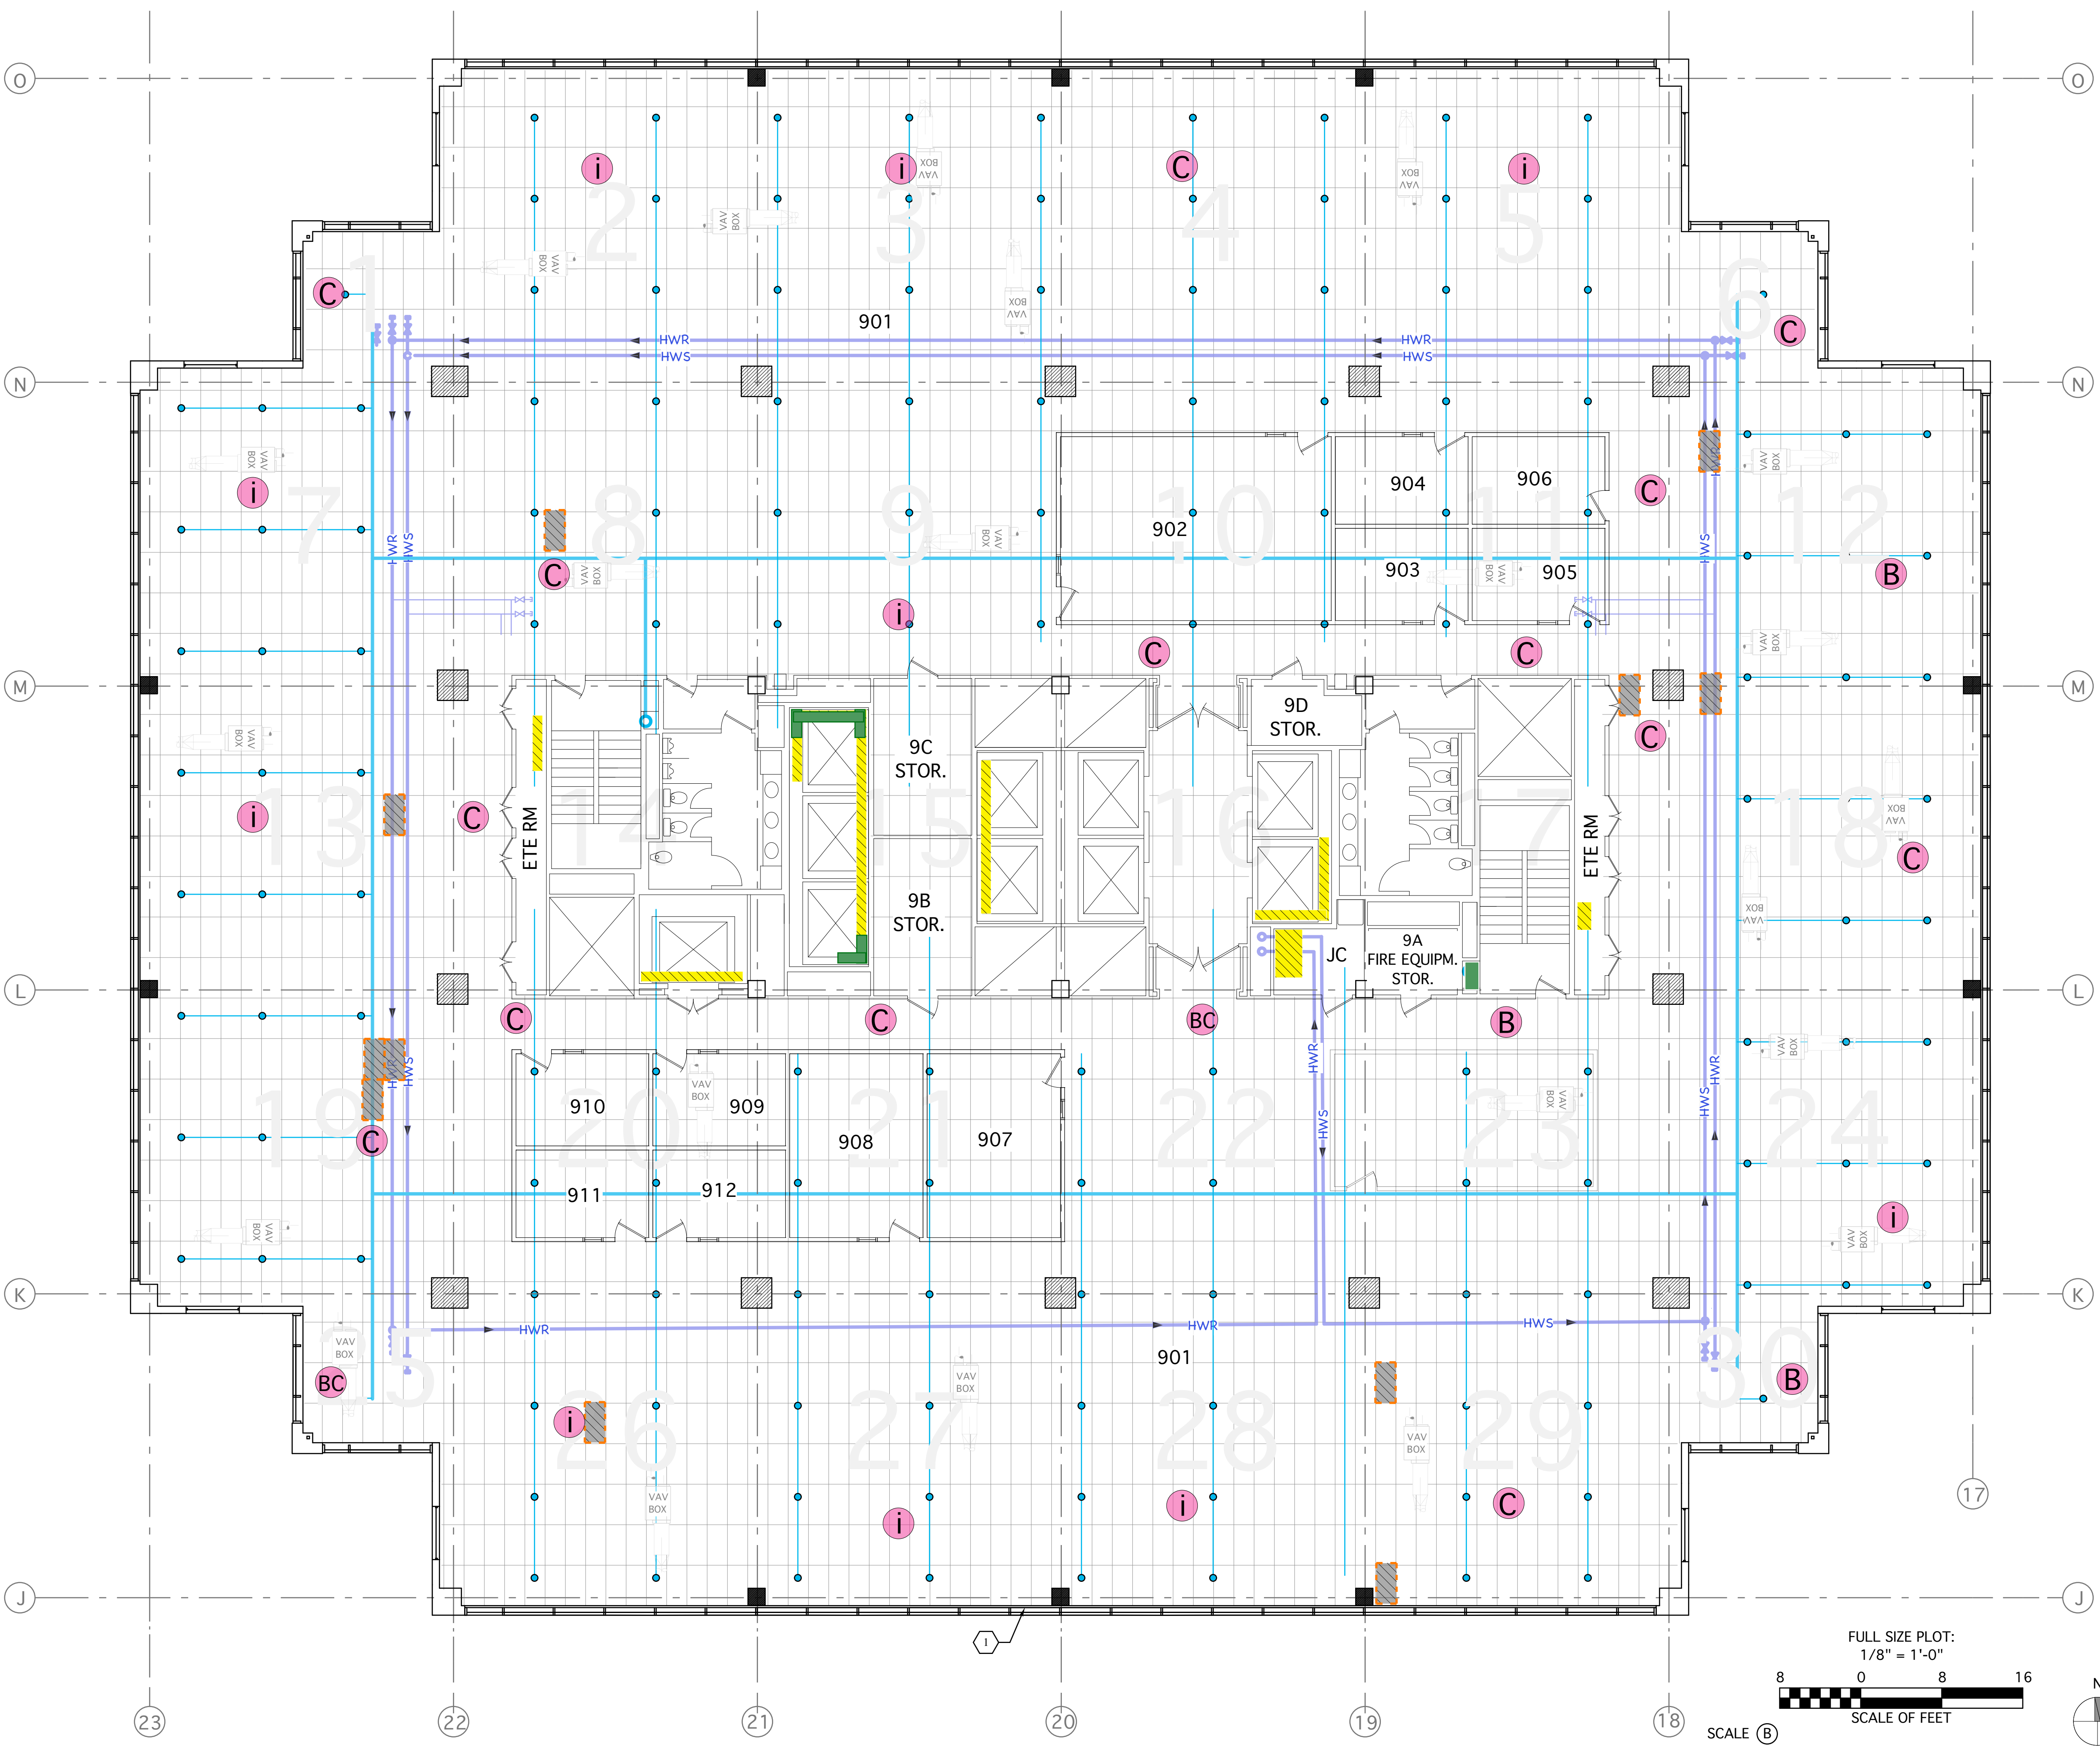
1 J/20 WS ON WINDOW SILL
(CURRENT)
